## **Effects of topographic and geological features on building damage caused by 2015.4.25 Mw7.8 Gorkha earthquake in Nepal**

Wang, F.W.<sup>1</sup>, Dahal, R.<sup>2</sup> and Li, T.L.<sup>3</sup>

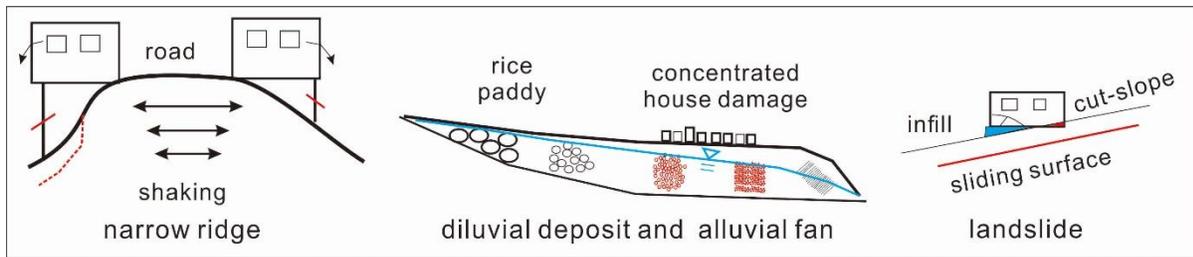
Through our investigation, we summarize the reasons of the house collapse and damages in Fig. 1. Fig. 1 (a) shows the situation on the narrow mountain ridges. Because the ridge is narrow, houses used non-homogeneous foundations. One side of the house is directly located on the ground, and the other side is supported by piles, bricks, or concrete structures. If the outside foundation is located in a landslide area, the foundation is prone to collapse even if the landslide does not show obvious displacement; if the entire mountain ridge is located on a landslide, the amplified shaking can cause any types of failure. Fig. 1 (b) represents the geological structure in Sankhu town. In the upstream side, gravel and surface water is abundant, but on the downstream side, the grain size of the soil becomes finer and finer, surface water becomes groundwater, and the groundwater gradually becomes deeper. Fig. 1 (c) shows the failure pattern at the Purano Naikap area. In this kind of area, the structure of the lacustrine deposits overlaying the bedrock can form an enhanced structure for the occurrence of landslides. Because the lacustrine deposit landslide mainly consists of clay, generally they will not move for a long distance during an earthquake, but they can amplify the shaking and cause general destruction to the houses, especially if the houses in this area were located on shallow foundations on cut-slopes at the upper side, and infilled at the lower side.

*Fig.1 Three main patterns caused the house collapse and damages in 2015.4.25 Gorkha earthquake. (a) Building damage along narrow mountain ridge; (b) concentrated house damage on alluvial fan; and (c) house damage on existing landslide*
