Paper Number: 233

Geo-engineered slope failure at the power house pit of a power project in the Himalayas, Himachal Pradesh, India – causes and remedies

Kumar, Ashok¹, Yadava, V.S.², Mehrotra, A.²

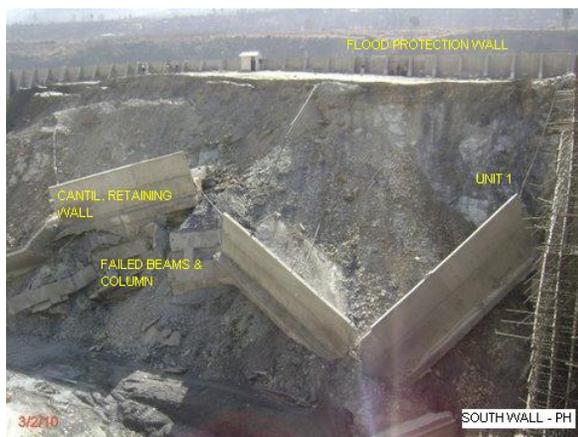
A geo-engineered slope, called southern wall, of a depressed and E-W aligned power house at 412 MW Rampur Hydroelectric Project in the state of Himachal Pradesh, India completely failed for its entire length of 111m on 2nd February 2010 (Figure 1) along with a 6m high cantilever retaining wall founded on rock at the top of the cut slope. The height of the cut slope in rock varied from about 13m in the middle to 20m at its eastern and western ends at the time of failure. About 20m deep power house pit, on the right bank of westerly flowing Satluj river, has been constructed within the thinly foliated carbonaceous phyllite (Kullu Group of Proterozoic age) trending parallel to sub-parallel to the power house alignment and dipping steeply towards north. There is a narrow rock ledge (20-30m wide) between the power house pit and the river, where a 10.5m diameter collection gallery tunnel has been accommodated. Southern cut slope of the power house pit was considered vulnerable to planer failure along prominent foliation joints. Accordingly, the designers incorporated this aspect in the design for protection of the wall, taking into account the orientation of the anticipated plane of failure. During the excavation of the pit, deformation/ movement of the rock mass was initially observed in August 2009, which increased with the passage of time. Keeping this in view, design was modified by incorporating enhancement of protection measures and strengthening of the rock mass. While measures to strengthen the rock mass and to contain its movement were at the execution stage, the whole length of the southern wall failed including the retaining wall at the top of the cut slope.

On analysis of the available pre- and post-failure data, reasons worked out for the failure were found to be the gentler dip (observed after failure) of the plane of failure than anticipated, i.e. adversely oriented foliation joints along southern wall of the pit, poor nature of rock mass, day lighting of the foliation

joints on the cut slope, non-crossing of the installed rock bolts beyond the actual failure plane and possibly the blast vibrations due to excavation of collection gallery. Suggested remedial measures for the restoration of the structure include completion of all excavations (requiring blasting in and around the pit) without disturbing the slide debris, protection of the rock slope above the slide material by shotcrete and rock bolts, toe support at the base and excavation of collection gallery without blasting, etc.

Figure 1: View of failed slope and retaining wall
