Paper Number: 2820

**Mechanism and control measures of a large deformation across the granite alteration zone in An Ping Tunnel**

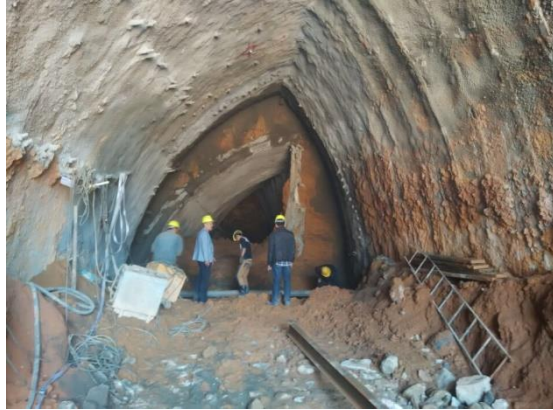
*Figure 1: Large deformation*
