Paper Number: 4677

Seismic Vulnerability Investigation of RDP homes in the city of Matlosana, North west Province, South Africa

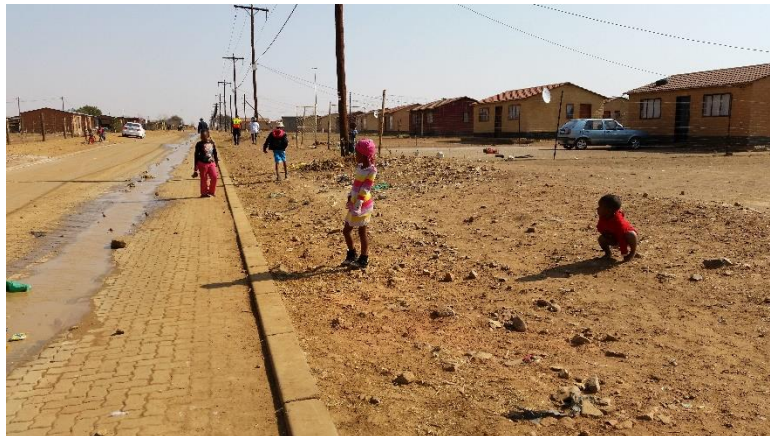
Fig 1: RDP homes in Kanana, South

It should be noted that most (if not all) of the outer wall of the RDP homes were made of a single brick layer instead of double brick layers. There was a repetition in the kind of damages noted. There were mostly corner cracks, damage above windows and above door openings, falling plaster and hairline cracks.

There were instances where the damage could be attributed to shoddy workmanship. In many cases there was an absence of supporting beams, brickforce and often not even enough cement/mortar between the bricks.
