The investigation and rehabilitation of the Pretorius Avenue sinkhole in Lyttelton Manor, Centurion

Stiff, J.S.¹ and Sudu, A.²

¹SRK Consulting (Pty) Ltd, Illovo, South Africa, jstiff@srk.co.za

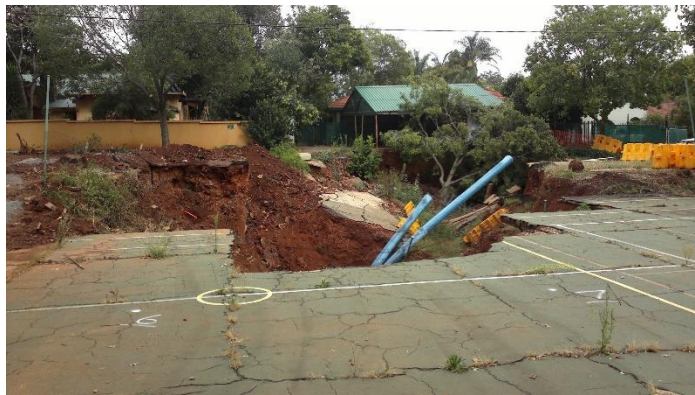
Pretorius Avenue in Lyttelton Manor. The sinkhole that developed was one of the largest sinkhole events to have occurred in the last 25 years in the Centurion area. The sinkhole measured 16m by 35m in dimension and up to 9m deep (Figure 1). The sinkhole affected the roadway, the private property, the sport facilities of the adjacent school and disrupted Municipal water, sewer and stormwater services to the area.

Figure 1: The Pretorius Street sinkhole shortly before commencement of rehabilitation.
