Paper Number: 2781

Geomorphology and rock slope instabilities in the archaeological site of Petra (Jordan)

Margottini, C.¹ and Spizzichino, D.²

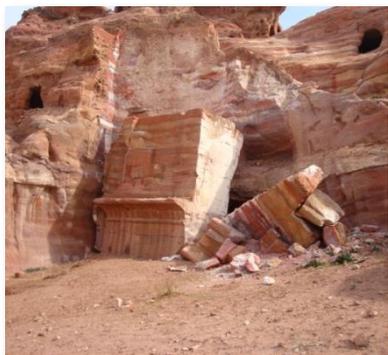
Figure 1: The Mu'essira tomb with the collapse

likely occurring on March 2010 (www. Petranationaltrust.org).
