Paper Number: 4983

Landslide hazard assessment through forcing activation of a landslide and conducting of monitoring

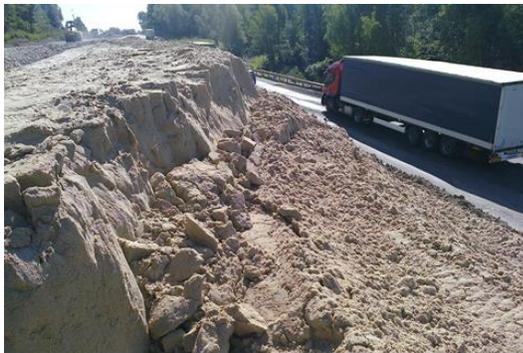
Fig. 1. Landslide crack on the embankment.

The landslide process was not considered by some professionals as the main reason of occurred deformations. Weak soils at the base of the embankment, possible subsidence properties of soils (loess soils), excessive watering of Foundation soils were supposed as the reason of deformations.

It was established that the main slip surface of the landslide was located at a depth of about 18 m. Slope stability analysis were performed. As the result of provided investigations it was proposed to change the construction project of the road parts which adjacent to the bridge. Also the most effective protection measures and monitoring schemes were developed.
