PHASE I ENVIRONMENTAL SITE ASSESSMENT

**Former Barrett Store
15 Randolph Avenue, Pulaski, Virginia**

Town of Pulaski and United States Environmental Protection Agency
USEPA Brownfields Assessment Grant Number: # BF – 963327-01-0

DAA Project Number: **B07226-05**

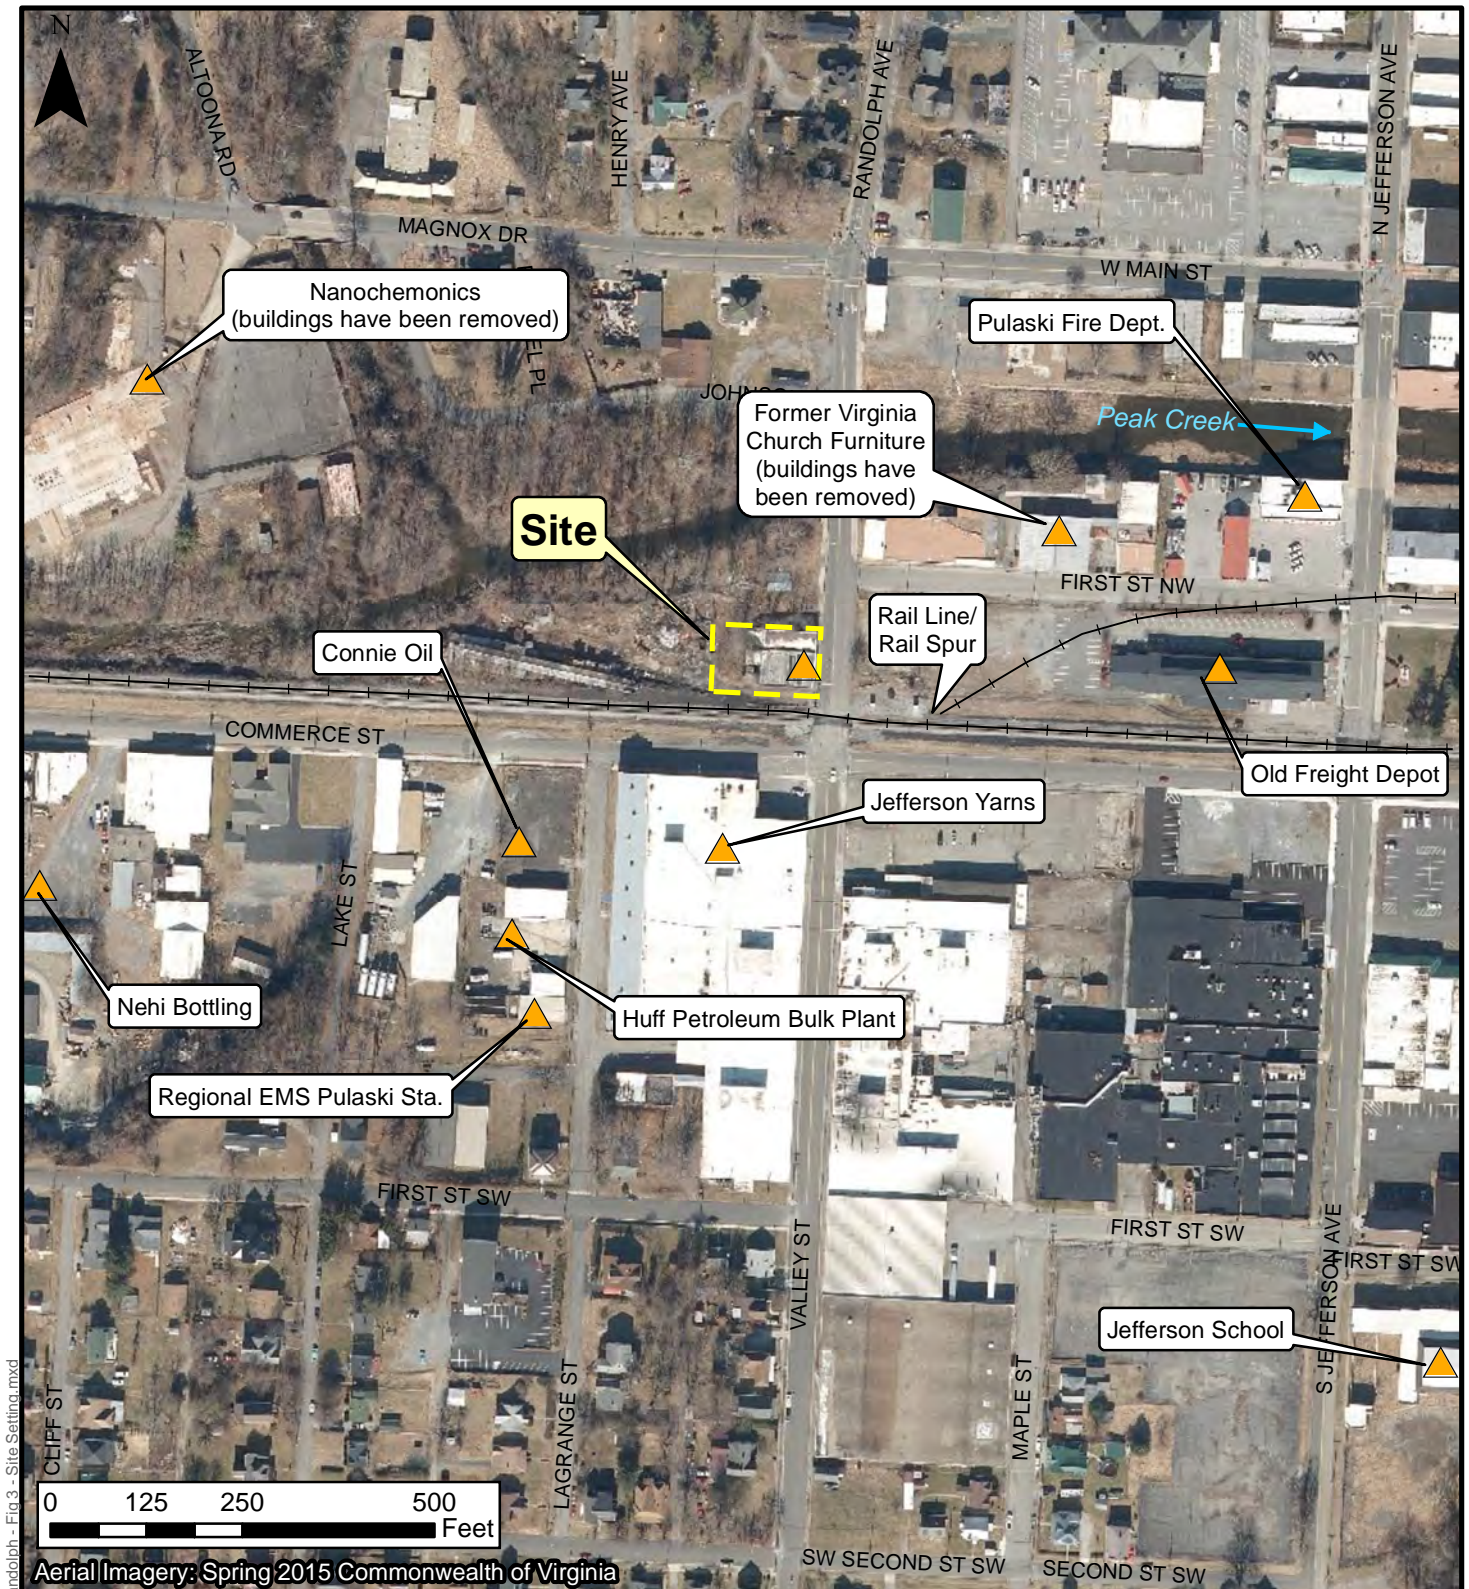
2

Site Setting Map

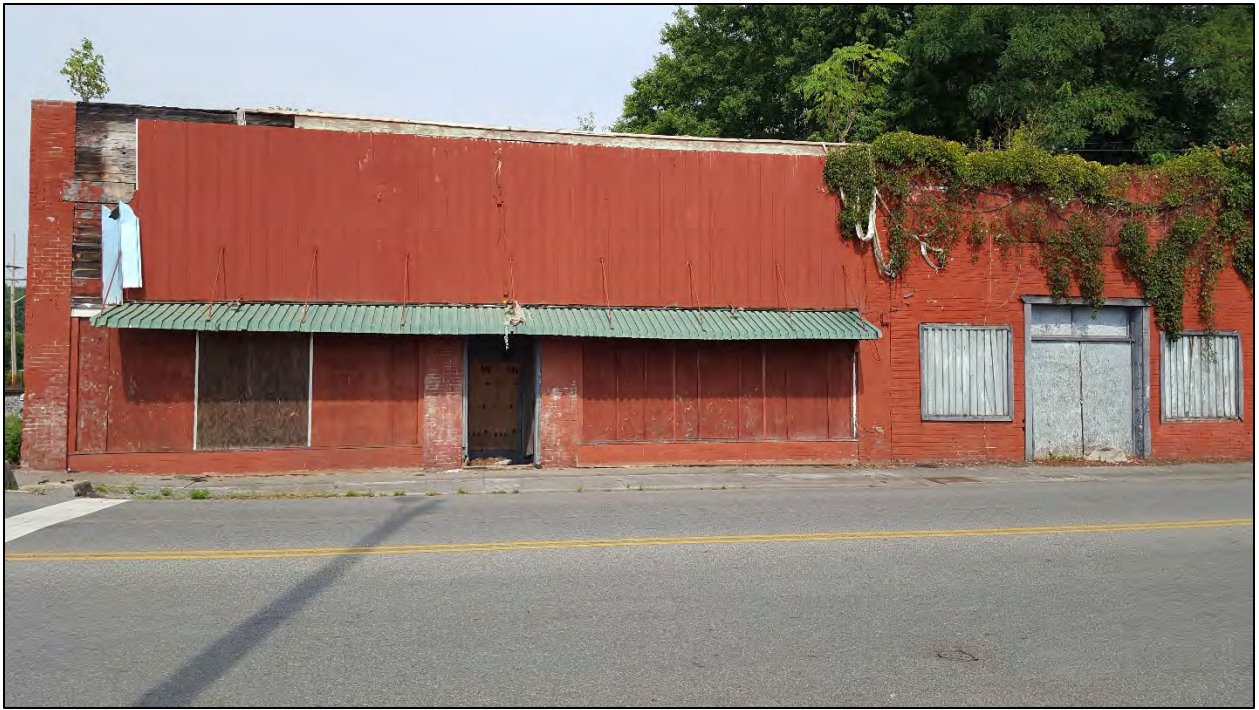
PHOTOGRAPH 3. July 2017. View of east side of subject property, facing west from across Randolph Avenue.

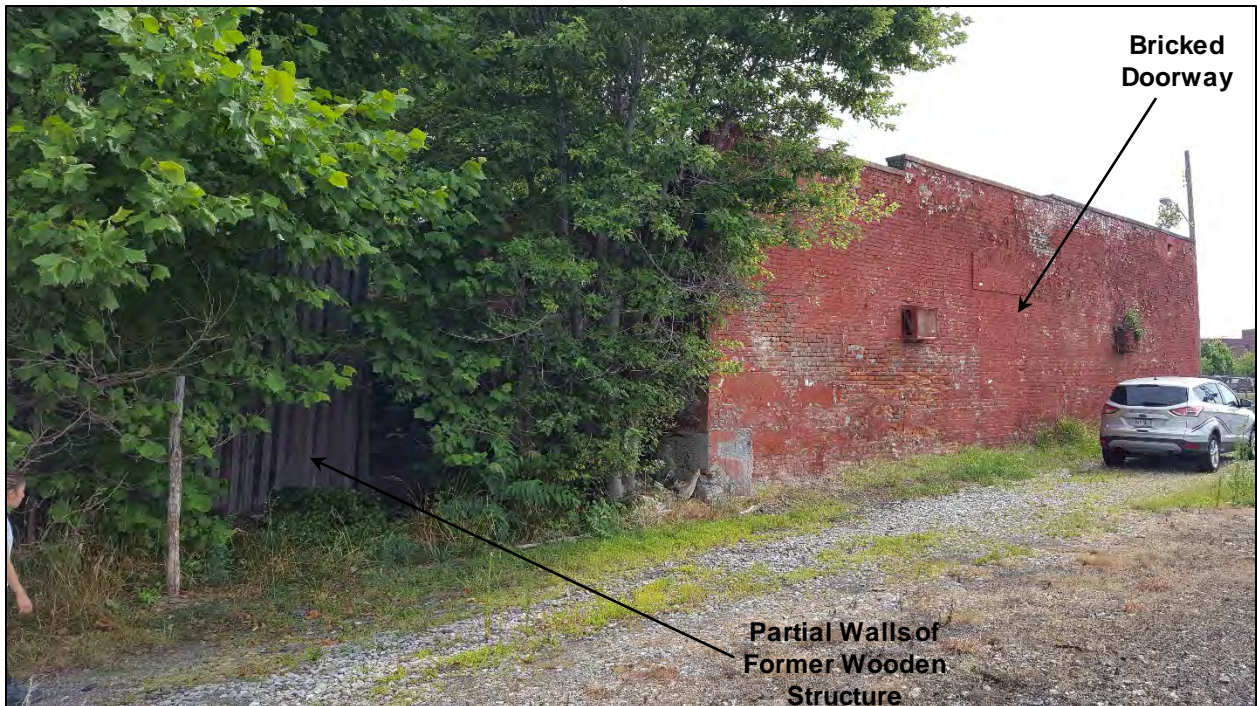
PHOTOGRAPH 4. View of south side of subject property, facing northeast from southwest property corner. Note partial walls of former wooded structure behind Main Building.

A concrete sidewalk is situated on the subject property on the east side of the structures. The main entrances to the Main Building and to the Former Auto Repair Garage are via Randolph Avenue to the east, with rear entrances on the western walls of both structures. A gravel driveway is located along the south side of the Main Building leading from Randolph Avenue to the rear of the subject property. The western portion of the subject property behind the two structures is overgrown with vegetation and contains partial walls of a former wooden structure behind the Main Building.

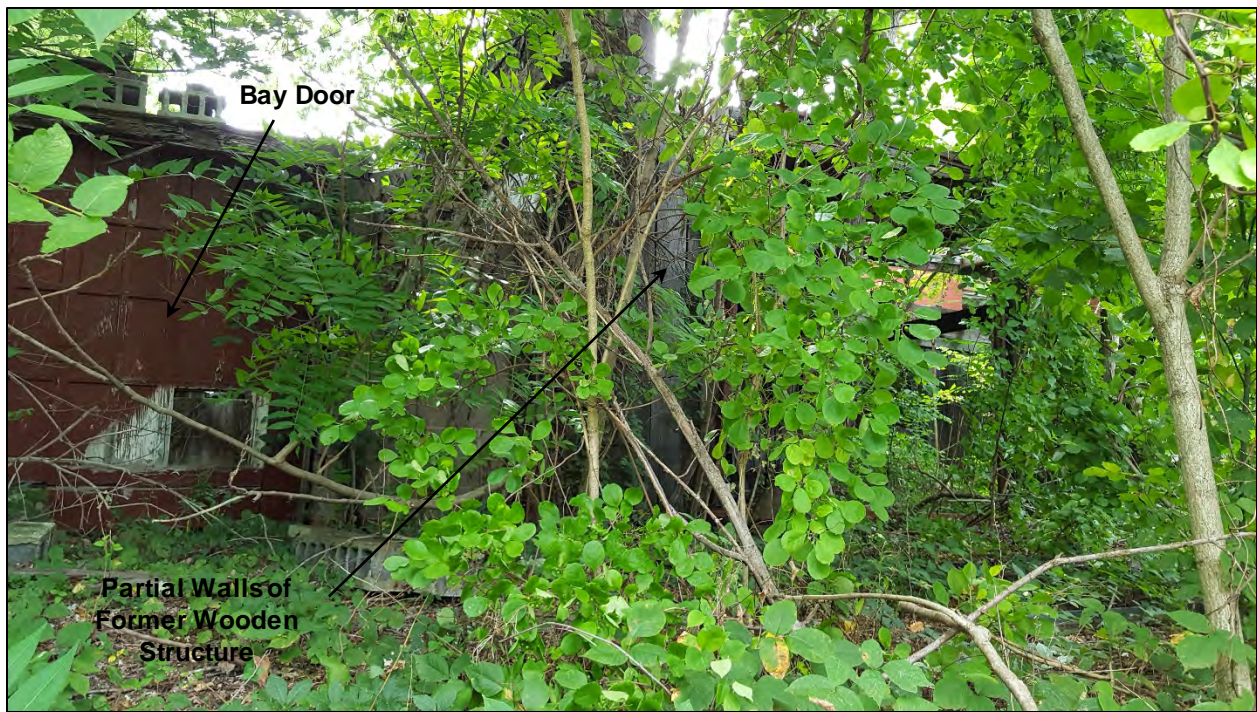
PHOTOGRAPH 5. View of west side of subject property, facing east from west adjacent property (vacant lot). Note overgrown vegetation, partial walls of former wooden structure behind Main Building, and rear bay door of Former Auto Repair Garage.

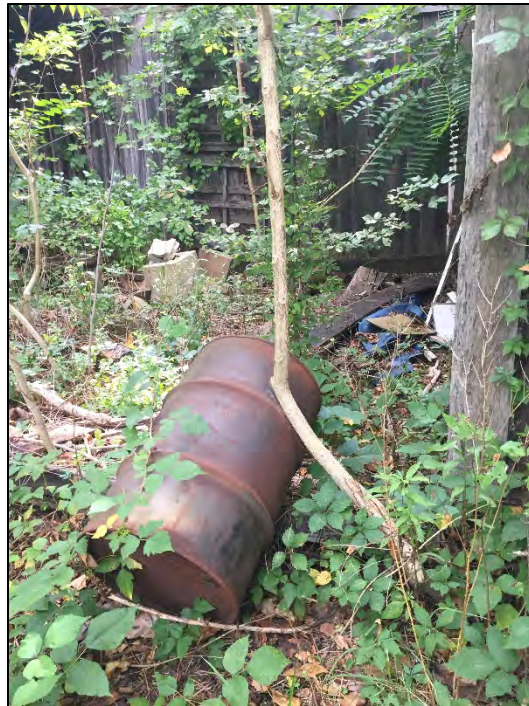
PHOTOGRAPH 6. Rusted 55-gallon drum (contents unknown) in overgrown vegetated area behind Main Building.

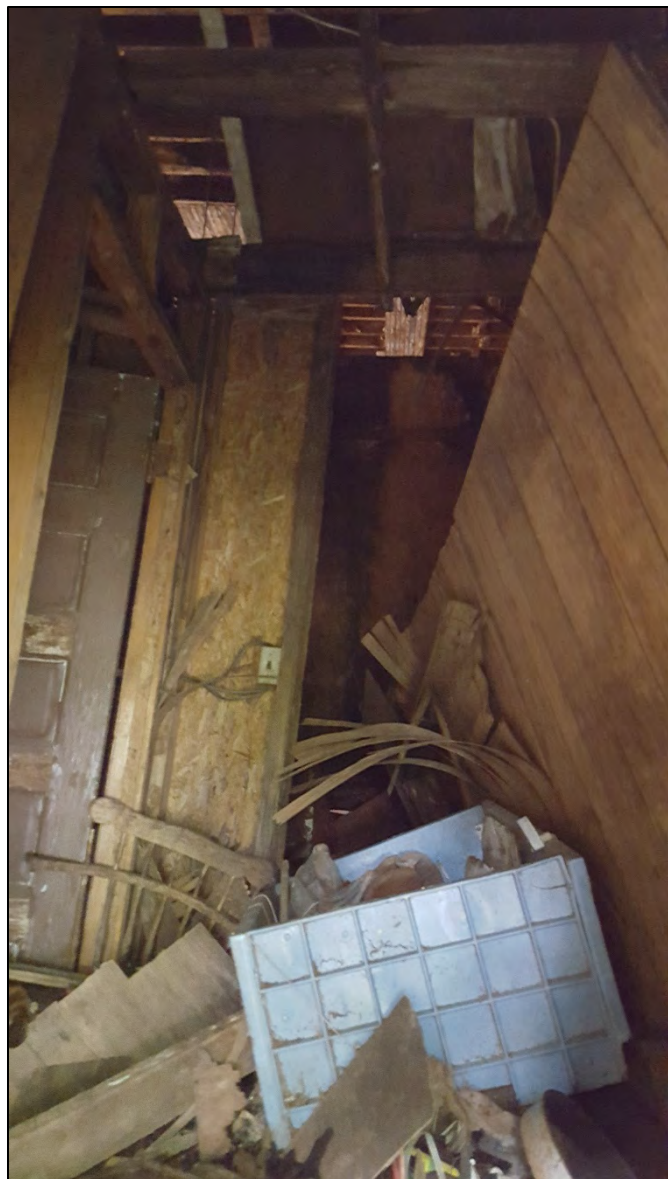
PHOTOGRAPH 8. View of collapsed interior of Main Building from rear doorway.

The Main Building and Former Auto Repair Garage are currently unoccupied. The interior of the Main Building has collapsed. The Former Auto Repair Garage is filled with miscellaneous refuse.

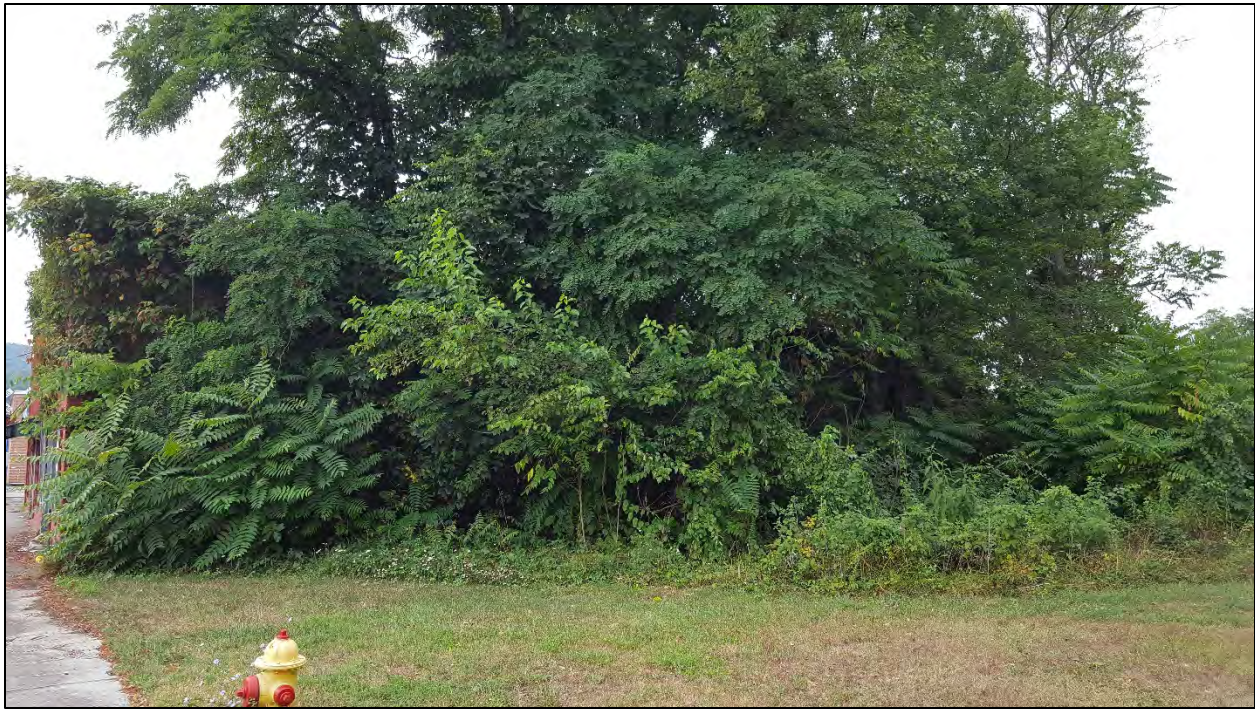
PHOTOGRAPH 9. View of north side of subject property, facing south from north adjacent property (vacant lot). Note overgrown vegetation covering north wall of Former Auto Repair Garage.

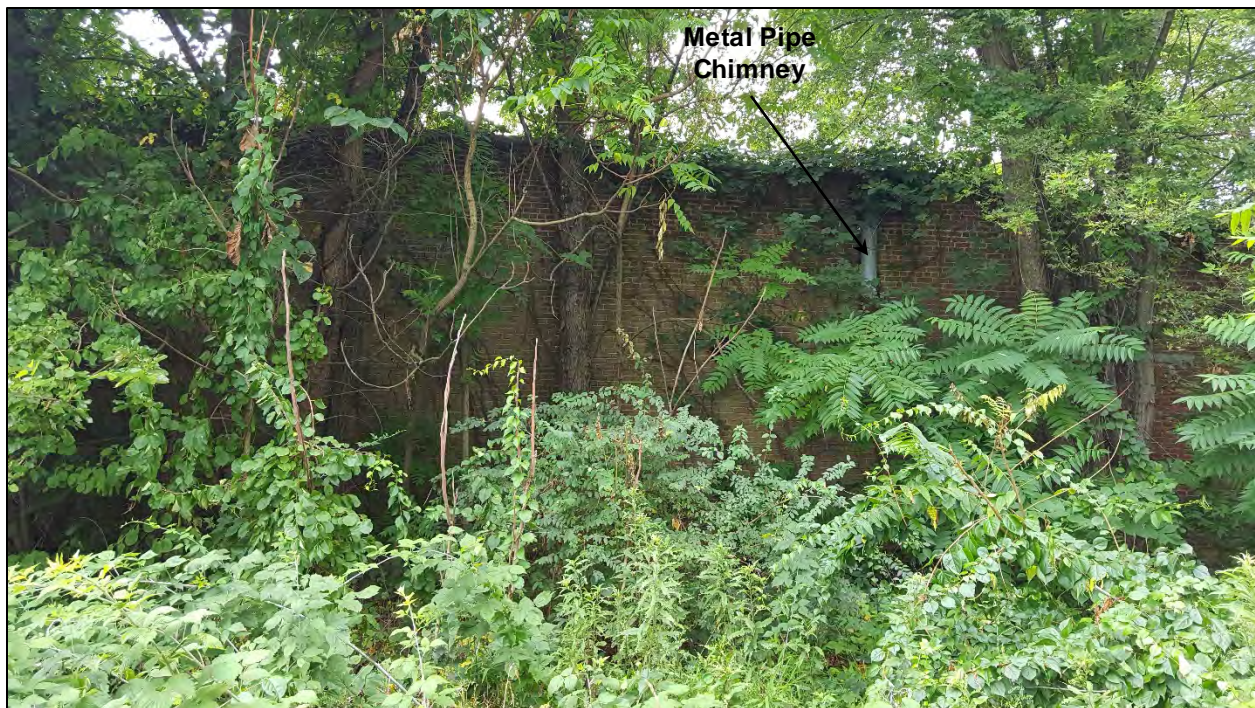
PHOTOGRAPH 10. View of exterior north wall of Former Auto Repair Garage. View from north adjacent property (vacant lot). Note metal pipe chimney.

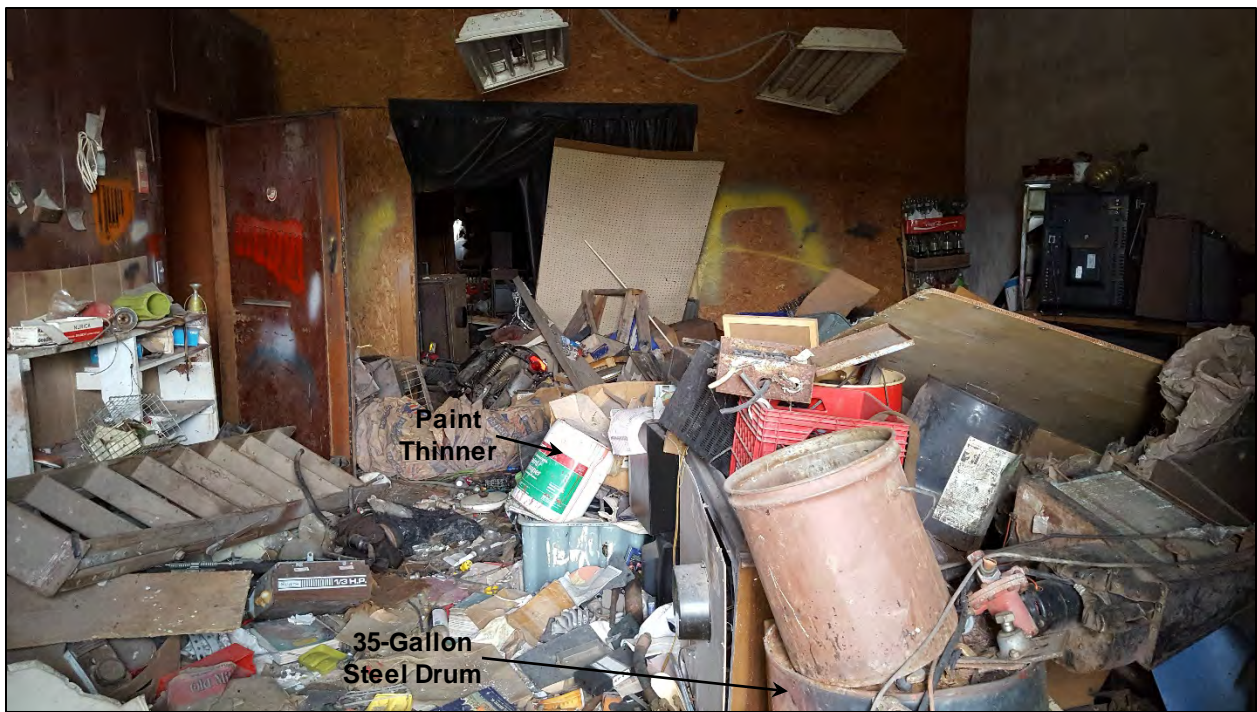
PHOTOGRAPH 11. Interior of front room of Former Auto Repair Garage. Note assorted refuse and debris, including (but not limited to) rusted 35-gallon steel drum (contents unknown) in foreground and paint thinner container.

- REC (subject property) – The site reconnaissance identified numerous containers of paint, paint thinner, and solvents; tires; automotive parts; a motorcycle; and old televisions among the refuse and debris within the Former Auto Repair Garage. Additionally, three rusted 55-gallon steel drums (two open drums filled with bottles, one closed drum with unknown contents) were observed in the overgrown vegetated area behind the Main Building. One rusted 35-gallon drum (unknown contents) and one collapsed 55-gallon

blue plastic drum (unknown contents) were observed among the refuse and debris within the front room of the Former Auto Repair Garage.

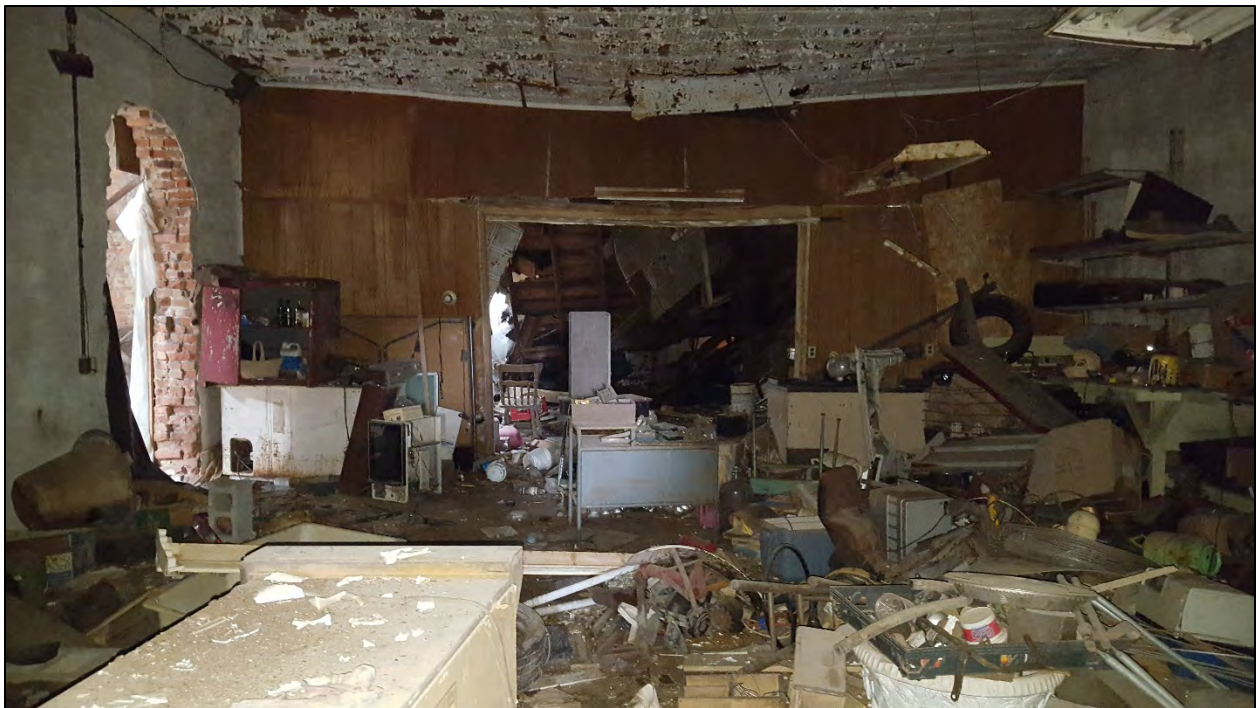
PHOTOGRAPH 12. Interior of middle room of Former Auto Repair Garage. Note assorted refuse and debris. Note sagging ceiling and water-damaged walls. View of collapsed rear room through opening in rear (western) wall of middle room.

The subject property is currently owned by Ms. Betty Johnston. The subject property is located at the northwest corner of the intersection of Randolph Avenue and a Norfolk Southern Railroad right-of-way, north of the intersection of Randolph Avenue and Commerce Street within the Town of Pulaski in a mixed-use area of development that historically and currently includes light industrial/manufacturing, government, religious, commercial, and residential, railroad, and undeveloped properties. The subject property is occupied primarily by a one-story Main Building and an adjacent one-story Former Auto Repair Garage. The Main Building was constructed in the late 1800s and primary use was a feed and hay store or grocery until late 1970s/1980s. Building renovations occurred since original construction. The Former Auto Repair Garage was constructed between 1920 and 1927 and use of petroleum storage was documented. Both structures are currently unoccupied and in poor condition. Draper Aden Associates conducted the site reconnaissance on July 27, 2017, however, interior portions were not observed due to the poor condition of the building. The roof and interior of the Main Building have collapsed into the basement. The walls and ceilings within the Former Auto Repair Garage exhibited damage from rainwater infiltration; the ceiling within the middle room is sagging and the ceiling within the rear room has collapsed.

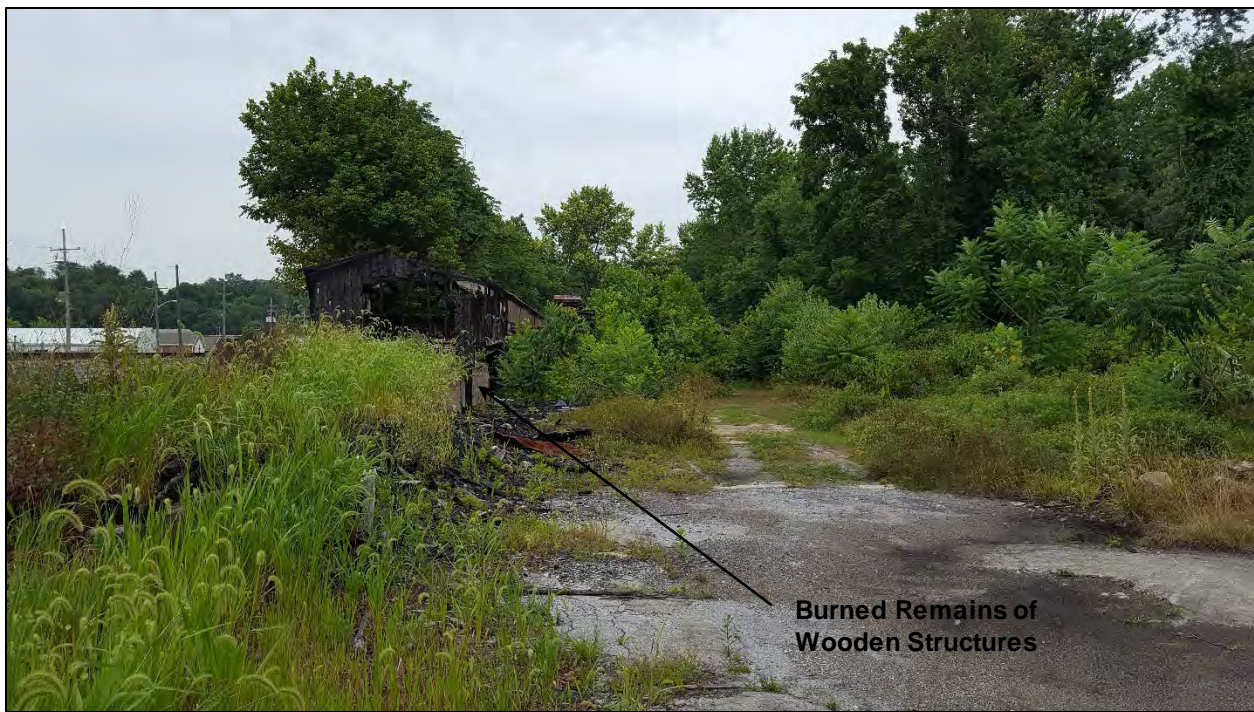
PHOTOGRAPH 13. Adjacent vacant property to west of subject property. View from southwest corner of subject property. Note burned remains of wooden structures.

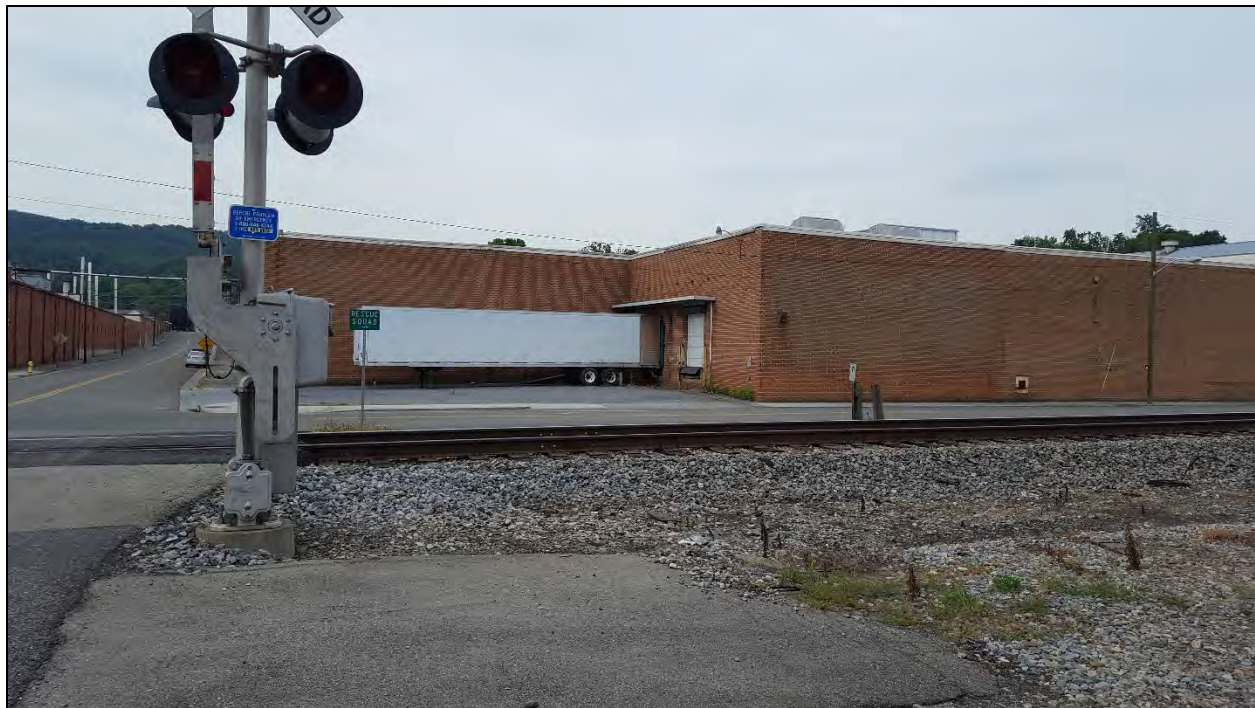
PHOTOGRAPH 14. Adjacent property (Norfolk Southern Railroad right-of-way) to south of subject property. View from southeast corner of subject property. Former Jefferson Yarns Hill Plant located to south of railroad right-of-way across Commerce Street.

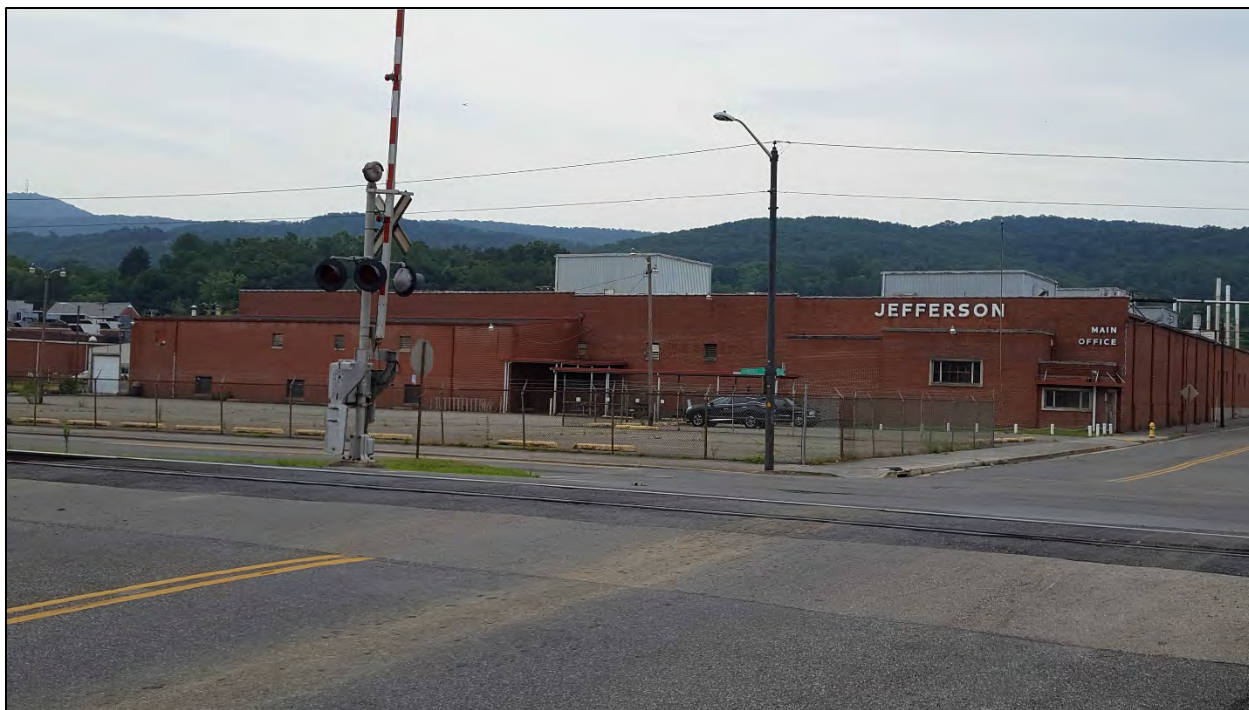
PHOTOGRAPH 15. Adjacent property (Norfolk Southern Railroad right-of-way) to southeast of subject property. View from southeast corner of subject property. Former Jefferson Yarns Main Plant located to southeast of railroad right-of-way across Commerce Street.

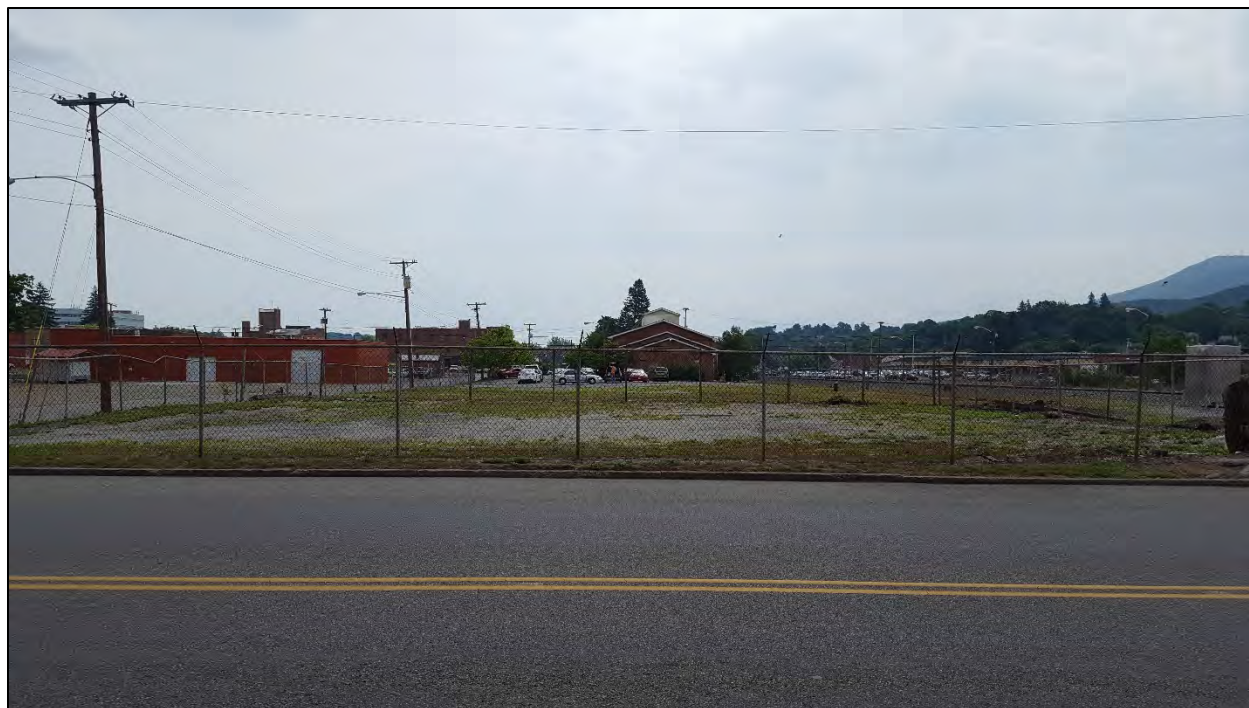
PHOTOGRAPH 16. Adjacent property (gravel-covered parking area) to east of subject property across Randolph Avenue. View from east side of subject property in front of Former Auto Repair Garage.

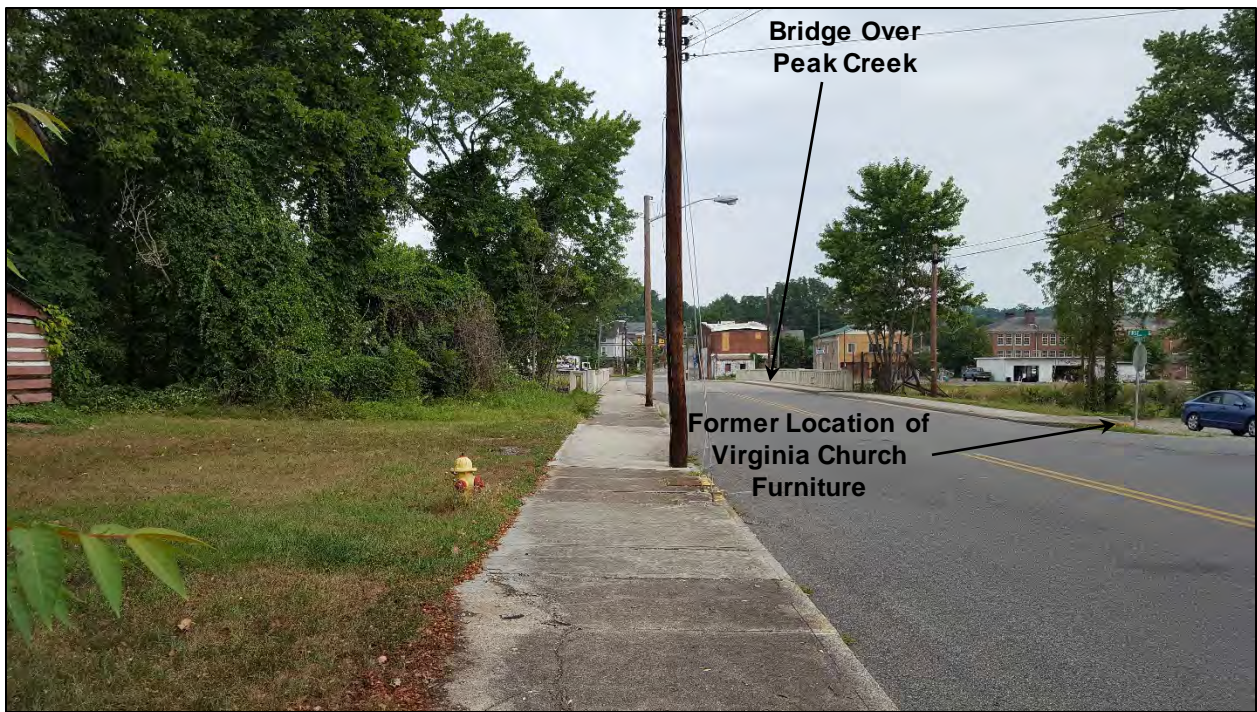
PHOTOGRAPH 17. View facing north along Randolph Avenue from northeast corner of subject property.

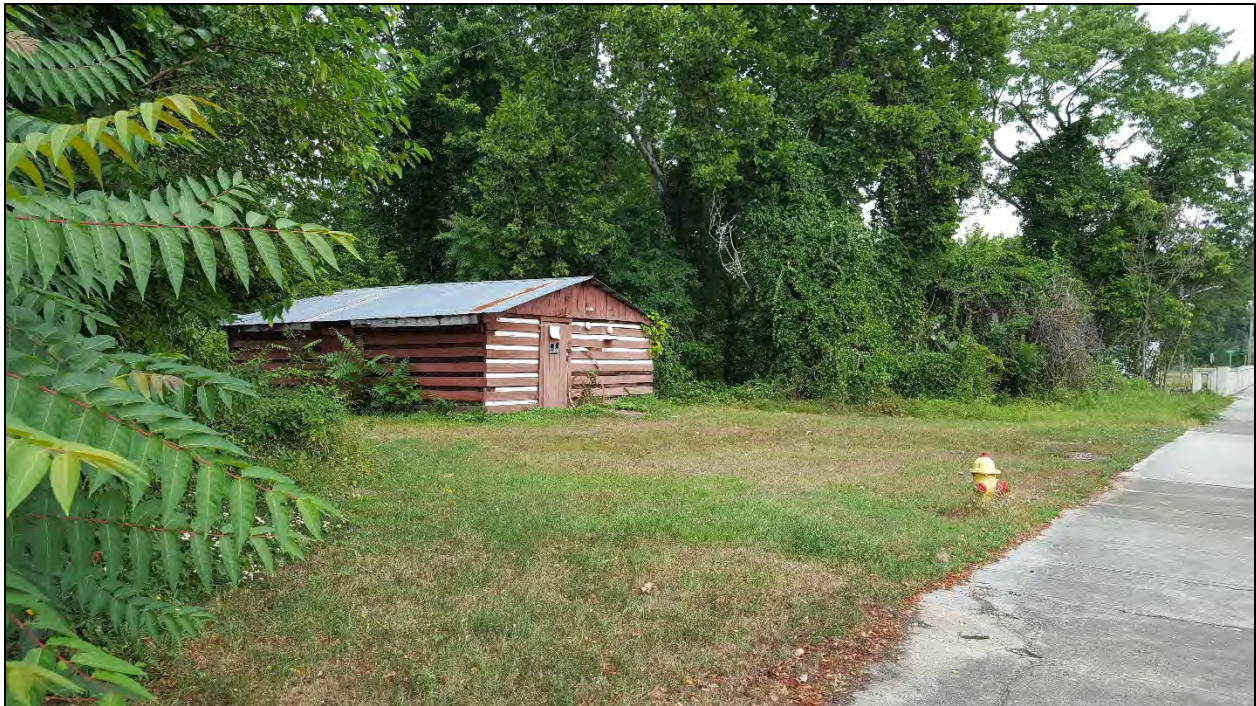
PHOTOGRAPH 18. Adjacent vacant property and vicinity properties to north of subject property. View from northeast corner of subject property. Note locked wooden structure of unknown use on vicinity property to north of subject property; two vacant parcels are located between this structure and subject property.
