Using Geologic Maps to Reduce Landslide Risk

Protecting public safety and infrastructure

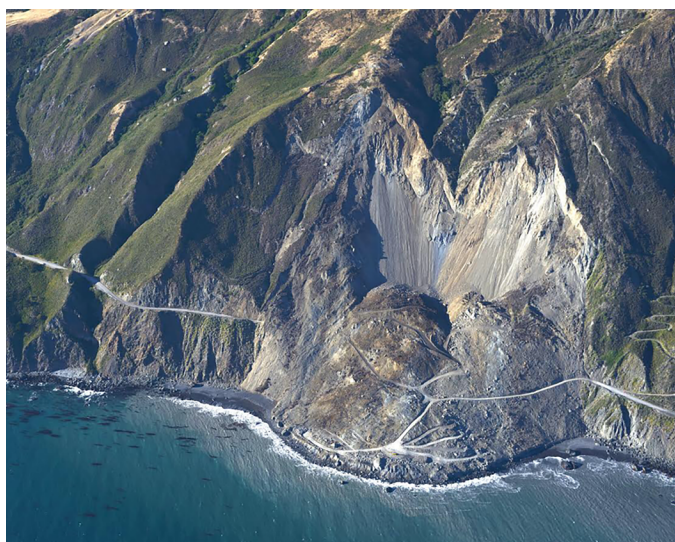
A major landslide in Big Sur, California in 2017 covered a quarter-mile of Highway 1. It was not the only landslide to limit access to the highway in 2017, and repair estimates exceed \$40 million. Image credit: Bob Van Wagenen (Public Domain)

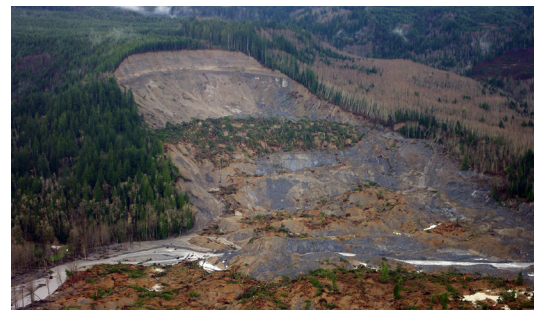
The 2014 Oso landslide moved an estimated 270 million ft³ of rocks, dirt, trees, and other debris down the slope. The direct costs for repair are greater than \$80 million.

The chance of a landslide is known to be markedly higher on or near the sites of previous landslides. Two recent major landslides in Washington State caused severe damage to nearby communities. In March of 2014, the devastating Oso landslide and resultant debris flow—a mass movement of loose rock, soil, organic matter, air, and water—claimed the lives of 43 people, destroyed 49 homes, and shut down a portion of a major road in the area for almost two months. Overall, the landslide covered about 262 acres of northwestern Washington. Comparatively smaller, the 2013 Ledgewood-Bonair landslide covered about 12 acres and resulted in no fatalities. However, the smaller landslide did put 20 homes at risk of structural damage or property loss and cut off access to a major roadway.

New geologic maps of both areas show previous landslides near the locations of the 2013 and 2014 landslides, and that the two landslides reactivated portions of older slides. The slope that failed in the 2014 Oso landslide had failed before, causing an estimated 15 major and many minor landslides over the past 6,000 years—including one as recently as 2006—but had never moved such a large volume of material. In 1997, reactivation of the 11,000-year-old Ledgewood-Bonair landslide – similar to the one that occurred in 2013 – destroyed a home. Detailed mapping undertaken since these landslides will inform future landslide hazard management decisions and may help the community, working with local and state authorities, to reduce the risk to lives and property.
