# Geologic Mapping and the Trans-Alaska Pipeline Using geologic maps to protect infrastructure and the environment

AGI Critical Issues Program: www.americangeosciences.org/critical-issues This work is licensed under a Creative Commons BY-NC-ND 4.0 license Case Study 2018-001 Written by Abby Ackerman for AGI, April 2018

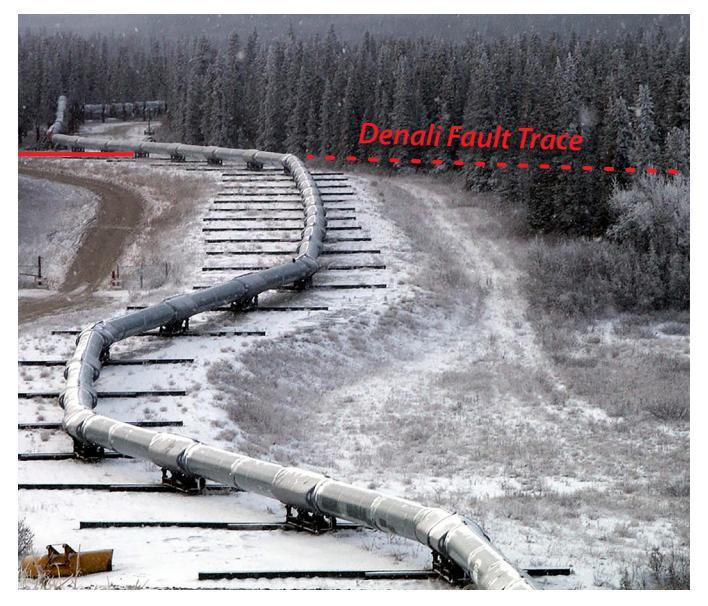
The Trans-Alaska Pipeline after the 2002 earthquake on the Denali fault. The fault rupture occurred between the second and third beams

Geologic mapping enabled engineers to develop a creative solution to protect the pipeline during a large earthquake on the Denali fault. They built the at-risk pipeline section on Teflon shoes mounted on long horizontal steel slider beams that run parallel to the fault. Fault movement and intense ground shaking during an earthquake would be accommodated by zig-zagging the pipeline, leaving it free to slide from side to side on the beams. This slider design was used in a corridor 1900 feet wide to accommodate uncertainties in the exact position of the fault at the pipeline crossing.

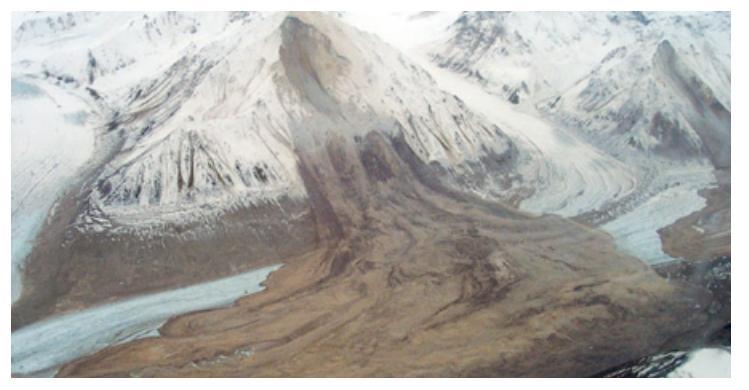
The 2002 Denali earthquake triggered a landslide on this 7,000 foot peak less than 10 miles away from the Trans-Alaska Pipeline. Image Credit: Jibson, Harp, Schulz, and Keefer, U.S. Geological Survey (Public Domain)

Following the quake, geologists carefully mapped areas affected by the earthquake. This mapping improved understanding of the earthquake risk in the area and revealed a previously unknown fault, the Susitna Glacier fault, where the earthquake began. Geologists also studied and mapped the pattern and distribution of landslides caused by the earthquake to help understand the landslide risk to the pipeline associated with earthquake shaking.

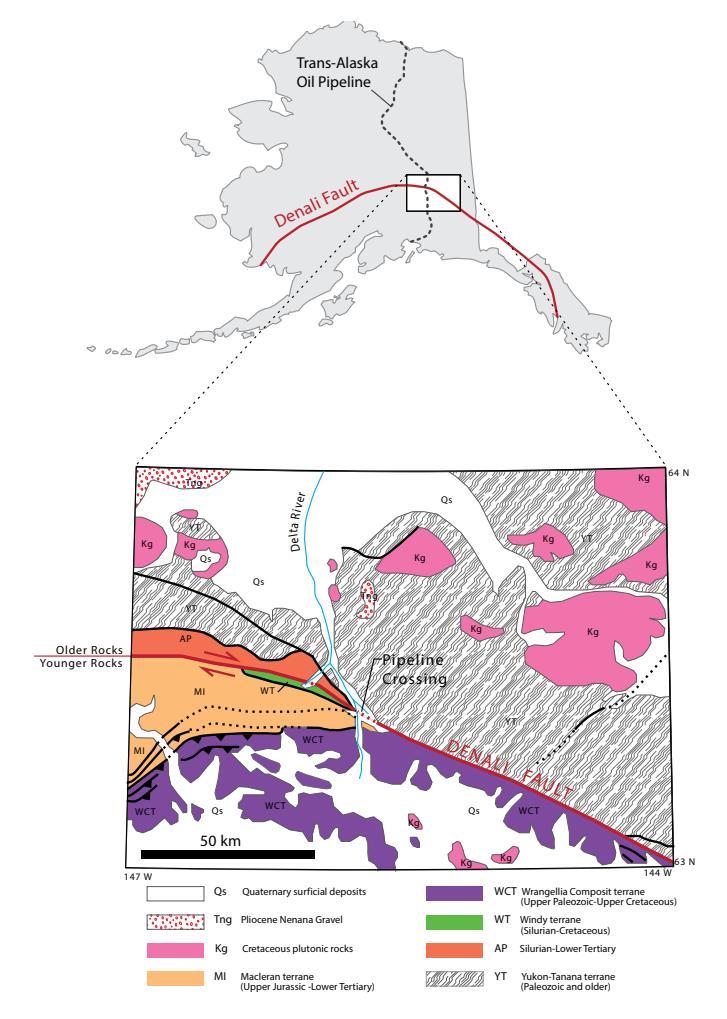
This map shows the geology of the area where the pipeline crosses the Denali fault. Rocks of different types and ages are juxtaposed on either side of the fault

The geology near the pipeline crossing showed older rocks on the north side of the fault that are side-by-side with younger rocks on the south side (see map, overleaf). Geologists then matched rocks of the same age on either side of the fault to determine how far the rocks had moved along the fault over time. Overall, the fault moved rock units 280 miles laterally over the past 55-65 million years, and between 294-492 feet within the last 12,000 years. By examining the fault closely and analyzing its rate of movement, geologists determined that the area around the pipeline crossing—had the potential to generate a very significant earthquake greater than magnitude 8.
