Paper Number: 1086

Rockfall hazard analysis in Deccan Plateau: A case study from Malshej Ghat, Maharashtra, India

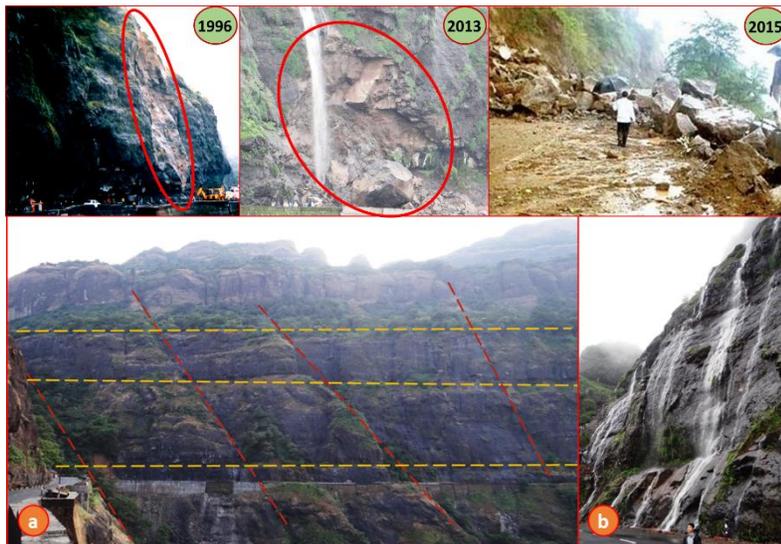
Figure 1: Major rockfall incidences occurred during the monsoon in 1996, 2013 and 2015 along Malshej Ghat section of NH-222, Maharashtra, India

Figure 2: (a) Fracture zones cutting across basaltic lava flows and controlling development of a linear, deep valley in Malshej Ghat area, (b) slope profile at 2013 rockfall site

Due to the high velocity movement of blocks, rockfalls are one of the most dangerous natural hazards in the steep and cliff slopes of the Deccan Plateau and frequently represent the main threat to the anthropogenic setting, potentially damaging urban areas, roads and highways. This work illustrates a case study of rockfall hazards in Malshej Ghat, Maharashtra, India. Owing to its importance as a popular tourist destination and an important communication route (NH-222) that is vulnerable to landslide hazard, serious risks are posed during the monsoon period. Several fatal accidents causing deaths and serious injuries due to landslides (mainly rockfall) were reported from Malshej Ghat (Fig. 1).

Malshej Ghat is covered by a series of peaks comprising several basaltic lava flows of Deccan Trap with the thickness of individual flows varying from a few to several metres (Fig. 2a). These flows are mostly horizontal and form flat topped hills with step-like terraces produced from differential weathering and erosion (Fig. 2b). The rockfall problem can be related to high pore water pressures generated during percolation of rain water along joints/fractures during prolonged rainfall, differential weathering, root growth or leverage by the roots of vegetation moving in high winds, erosion and slope unloading and progressive opening of joints or a combination (Fig. 1, 2a and b).

depends on the geometry of the slope (Fig. 2b) and the initiation zone of the falling block. Blocks falling from greater heights above the road often crossed the road without contact with it and on the other hand, when the point seeder was positioned at lower heights above the road, the rocks fell directly on the road. The computed bounce height, kinetic energy and translational velocity as well as rockfall trajectory for different slopes should be considered to design barriers. The trajectory is helpful for deciding the position of barrier. The bounce height, kinetic energy and translational velocity are useful in determining the strength and height of the barrier. These analyses aid in building effective barriers and/or rock catch areas for mitigation of rockfall hazards in protection of NH-222 in Malshej Ghat.
