Paper Number: 2805

## Geomorphology and rock slope instabilities in the archaeological site of Petra (Jordan)

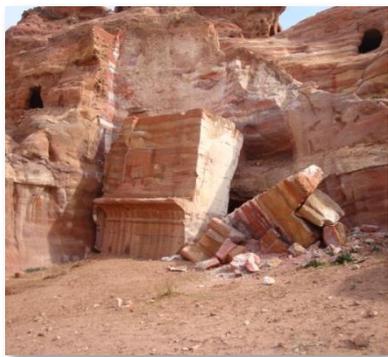
*Figure 1: The Mu'essira tomb with the collapse likely occurring on March 2010 (www. Petranationaltrust.org).*
