Variations in the morphology of reactivated fault scarps in the UK

Donnelly, L.J.¹, Culshaw, M.G.²

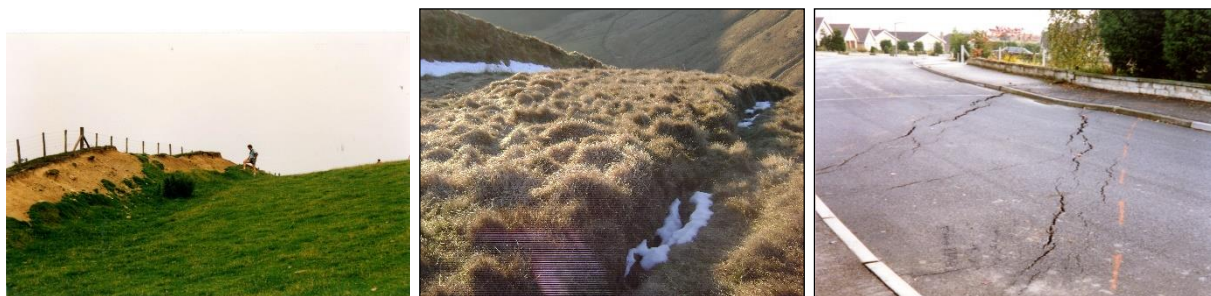
Figure 1 Variations in fault scarp morphology: (Left) Uphill facing, linear, fault scarp above the crest of Troedrhifwuch landslide, South Wales, UK. (Middle) Two parallel scarps, Tableland Fault scarp, South Wales, UK. (Middle) Small graben, Derbyshire, UK.

Reactivated faults scarps have been documented throughout the United Kingdom (UK) generated during coal mining subsidence. However, some fault scarps, such as those located on the interfluvial and moorland plateaux in the South Wales Coalfield and the Namurian sequences in the Pennines (where mining has not taken place) may have been initiated during valley deglaciation in the Pleistocene, whereby, stress relief and gravitational rebound and lateral spreading of the valley sides followed, or occurred simultaneously with, the retreat of glaciers. However, this is somewhat difficult to prove and geological evidence is still being sought to prove this theory. Other fault scarps, such as those in northern Scotland have also been interpreted to have been induced by palaeoseismicity associated with the retreat of ice sheets. This paper presents details of the variations in the morphology of reactivated fault scarps, which have been observed by the authors over a period of approximately 25 years. This paper also explores why fault scarp morphology is variable. When considering fault scarp morphology scale is also relevant. For example, scarps can appear as a single dislocation on aerial photographs but may comprise multiple smaller dislocations and sub-scarps when observed on the ground (*the Russian Doll Effect*). Faults scarps vary considerably and can be traced along the ground surface as a single dislocation or as a zone of multiple sub-scarps. They can vary from less than 0.1m to over 4m high, and from a less than a metre to several kilometres long across moorland slopes. Furthermore, fault scarp displacement may be vertical (usually 'normal', but sometimes 'reverse'), lateral (strike-slip), compressional or dilatational, resulting in the generation of compression humps or fissures, respectively. Fault scarps may be linear or sinusoidal and they may diffract and reflect along the ground surface (Figure 1).

hardstanding, macadam roads or paved areas tend to have more distinct, steeper morphology. Faults that outcrop in weaker granular or cohesive soils have a less distinct scarp over a broader area up to several metres wide. In urban and agricultural areas reactivated fault scarps tend to be temporary features of the landscape. Soon after their generation they may become degraded by anthropogenic activities such as ploughing, road and structural repairs or building and construction. By comparison, in areas of higher relief and relatively remote parts of Wales, Scotland and the Pennines some of the fault could be tens to thousands of years old. However, this remains speculative and further research is required to accurately and invasively investigate, map, record and date the origin of these fault scarps to better understand their origin and evolution.
